November 2001

LAND MANAGEMENT AGENCIES

Restoring Fish Passage Through Culverts on Forest Service and BLM Lands in Oregon and Washington Could Take Decades

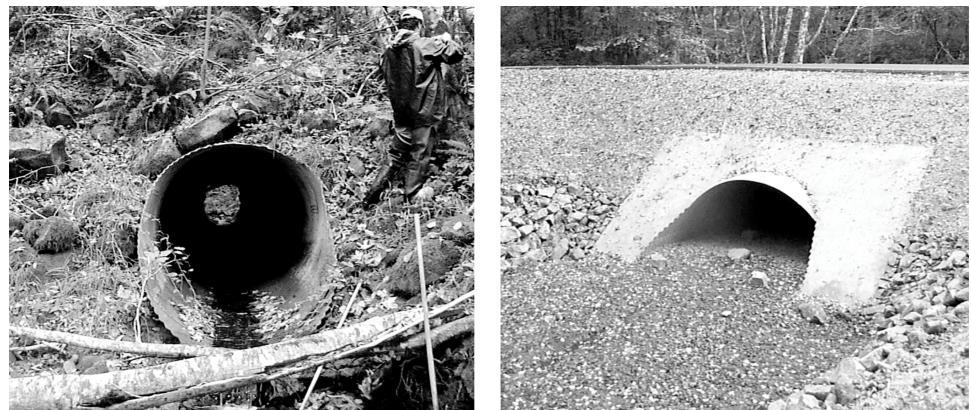
Figure 1: Culvert Before and After Replacement

Culverts—generally pipes or arches made of concrete or metal—are commonly used by BLM and the Forest Service to permit water to flow beneath roads where they cross streams, thereby preventing road erosion and allowing the water to follow its natural course. Culverts come in a variety of shapes and sizes, designed to fit the circumstances at each stream crossing, such as the width of the stream or the slope of the terrain. Historically, agency engineers designed culverts for water drainage and passage of adult fish. However, as a culvert ages, the pipe itself and conditions at the inlet and outlet can degrade such that even strong swimming adult fish cannot pass through the culvert. The agencies remove, repair, or replace culverts to restore fish passage, as shown in figure 1.
